INSPECTION REPORT

For the Property at:
1234 SAMPLE STREET
CENTREVILLE, MD 21617

Prepared for: JOSH SAMPLE and SAMPLE INSPECTION
Inspection Date: Wednesday, April 6, 2016
Prepared by: Bobby Davidson, 31062

Report No. 1452, v.6

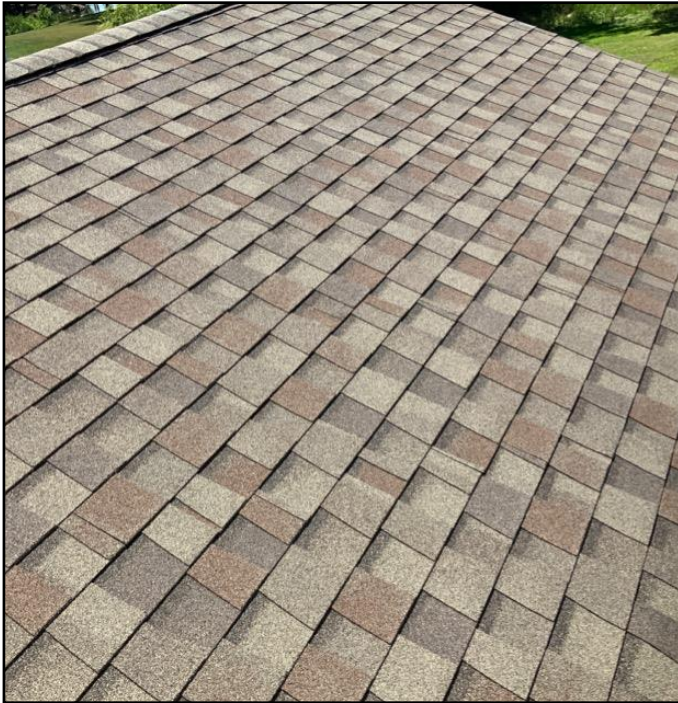
1.

- Architectural asphalt shingles. General life expectancy of material 30+- years
- 14 year old architectural shingle.

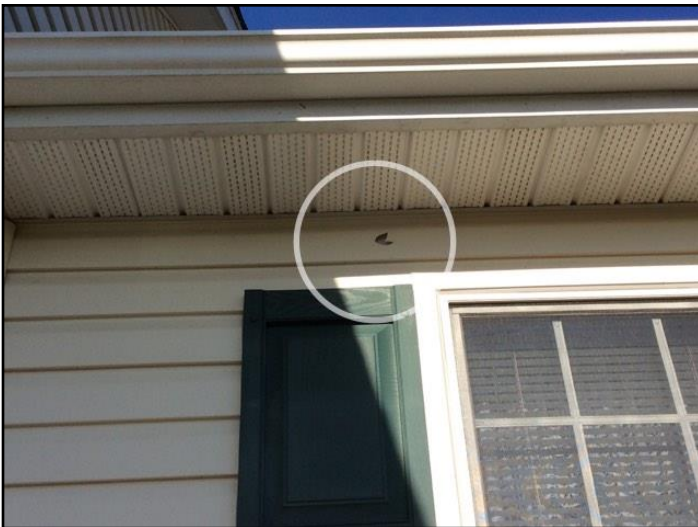
1. Condition: • Mechanical damage

There is a chip out of the siding to the right of the front porch and a small missing piece on the left rear side dormer.

Implication(s): Chance of water damage to structure, finishes and contents

3. Mechanical damage

Task: Repair

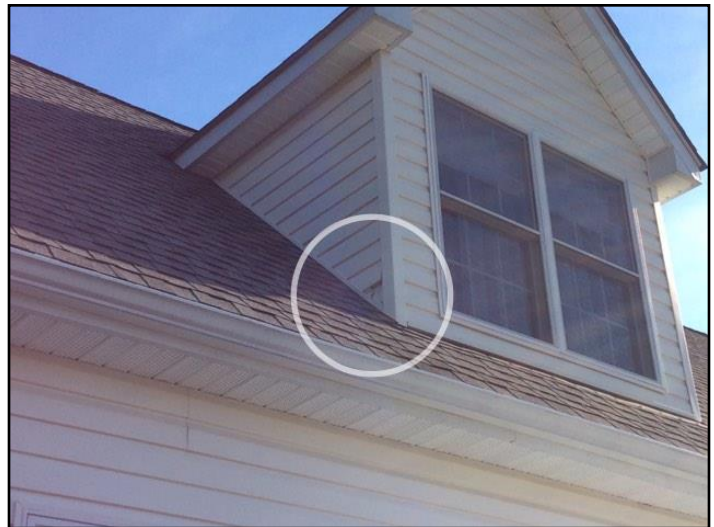
4. Mechanical damage

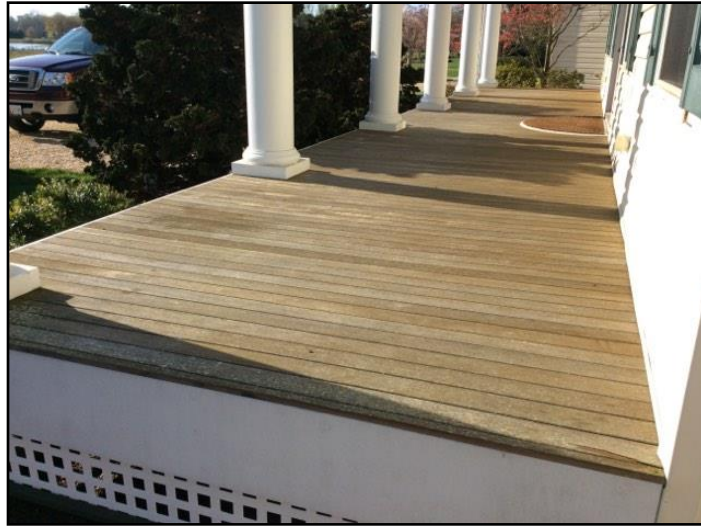
3. Condition: • Paint or stain needed

Implication(s): Shortened life expectancy of material

Location: Porch Front

5. *Paint or stain needed*

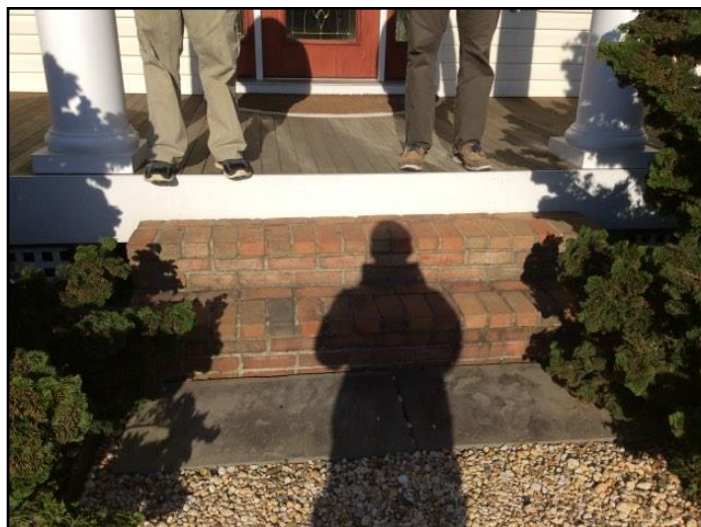
4. Condition: • Missing

Implication(s): Fall hazard

Location: front porch steps

6. *Missing*

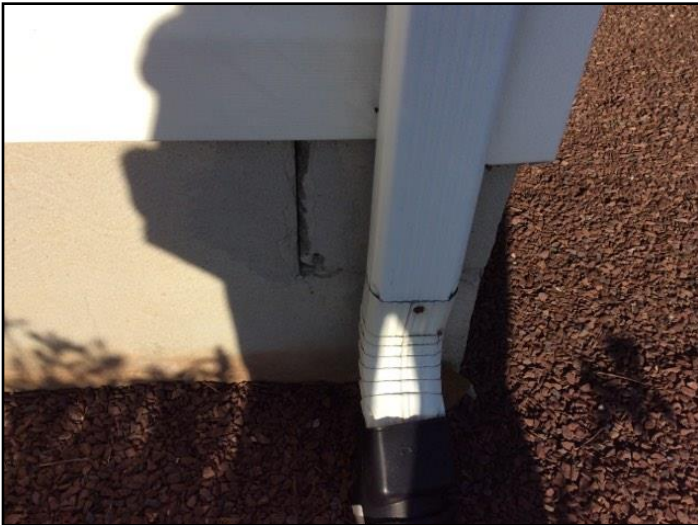
5. Condition: • Typical minor cracks

Implication(s): Chance of water entering building

7. Typical minor cracks

Seal varies minor cracks.

Task: Repair

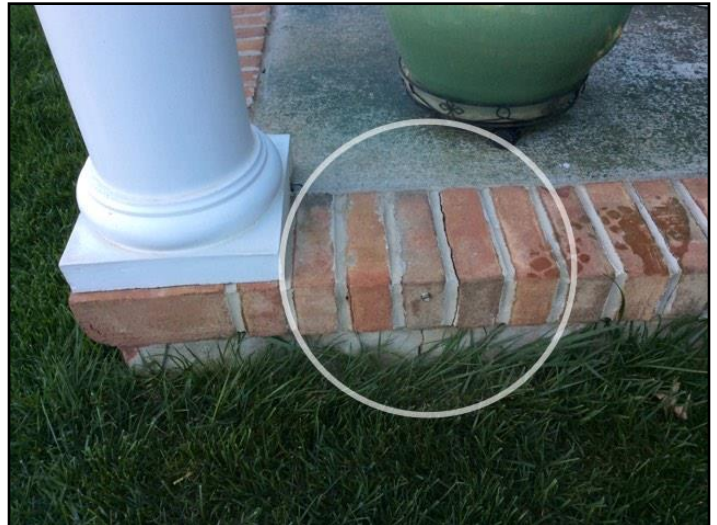
8. Typical minor cracks

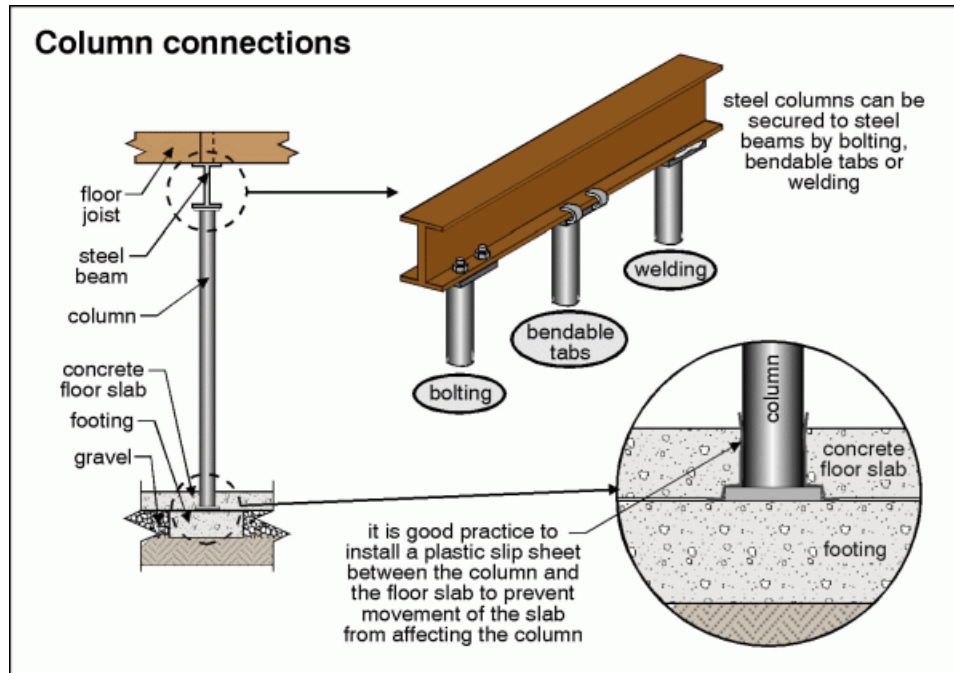
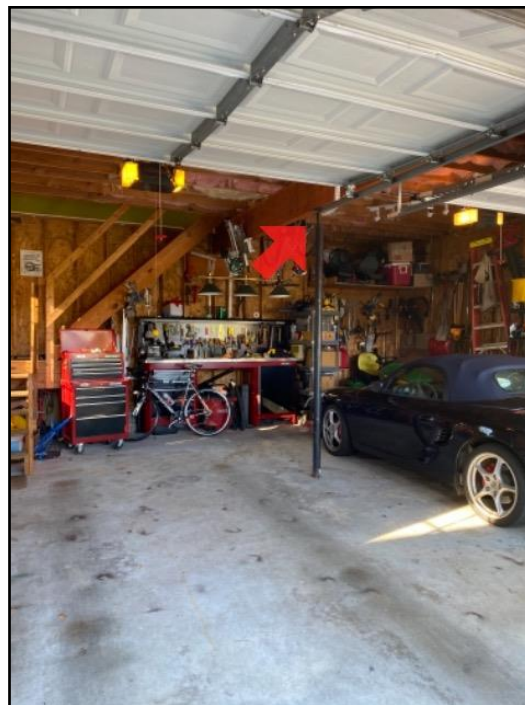
9.

Condition: • Weak connection to column

The metal column for the beam above the garage was bumped and has shifted off of the beam center. Recenter and properly attach with lags.

6. Condition: • Weak connection to column

Implication(s): Weakened structure

Task: Repair

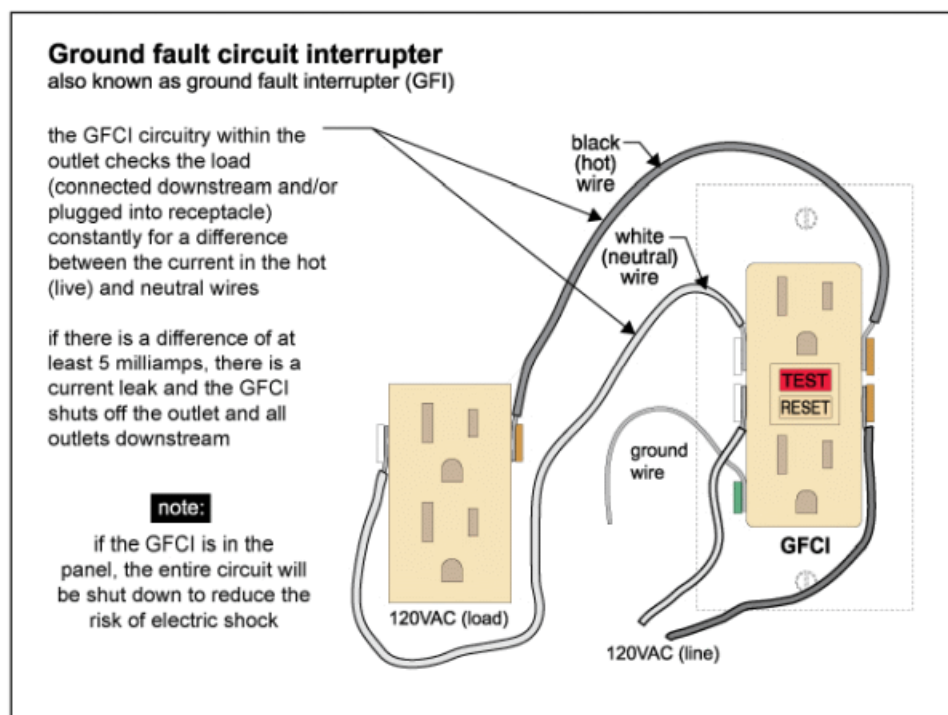
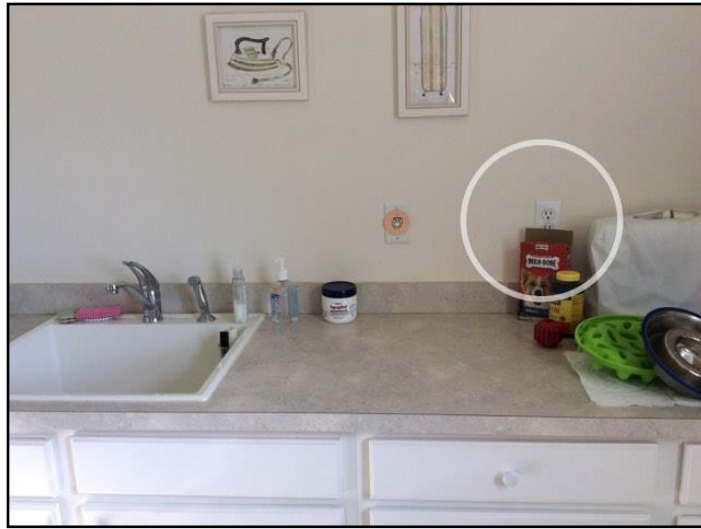
7. Condition: • GFCI/GFI needed (Ground Fault Circuit Interrupter)

Implication(s): Electric shock

Location: laundry counter outlet.

10. Ground Fault Circuit Interrupter (GFCI)...

Task: Repair by licensed expert

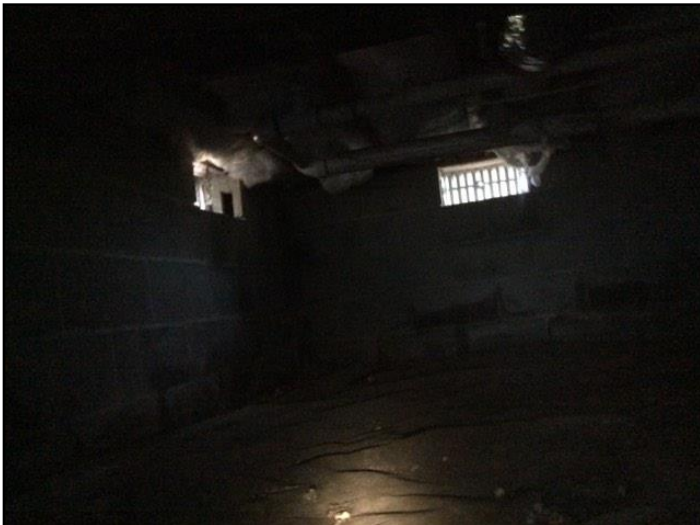
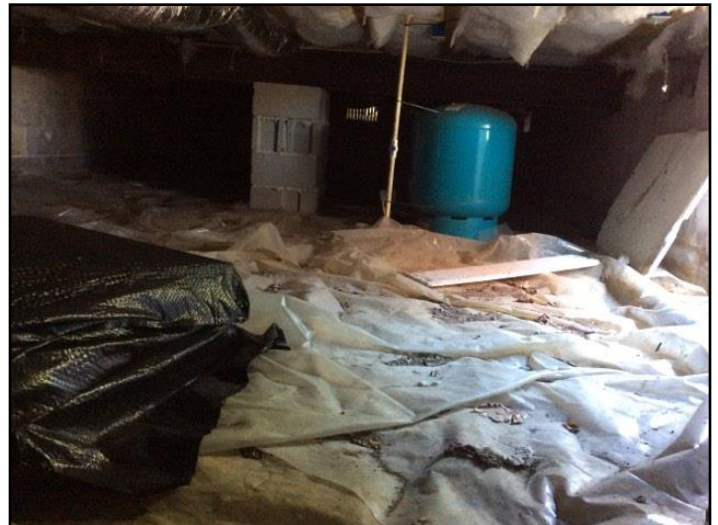
14.

9. Condition: • The crawlspace is average for the age although consider encapsulation long term as it is the new standard for crawlspaces.

Implication(s): Possible condensation moisture damage.

Task: Upgrade

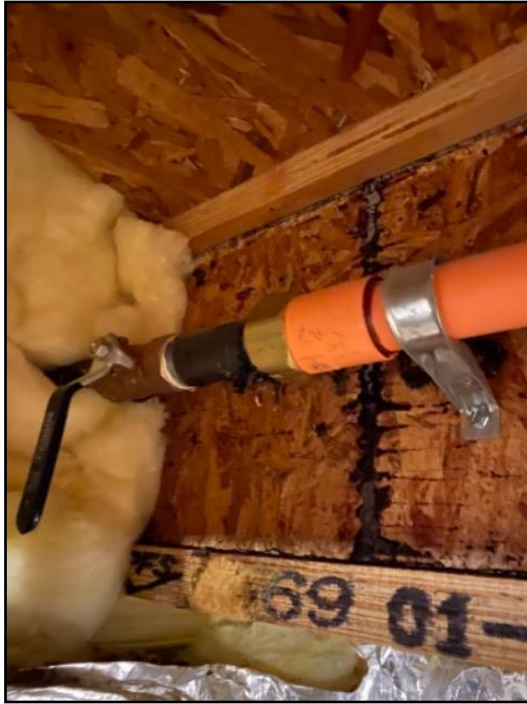
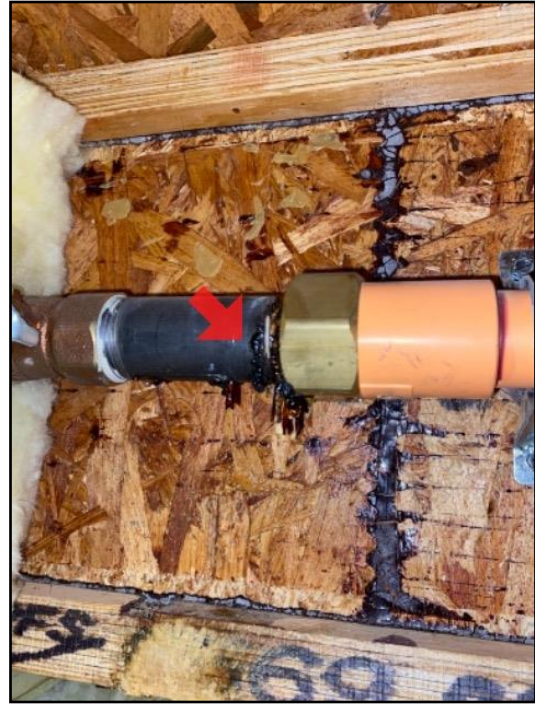
18.

Condition: • Leak

Leaking joint at the right rear corner of the crawlspace.

10. Condition: • Leak

Implication(s): Chance of water damage to structure, finishes and contents

Task: Repair

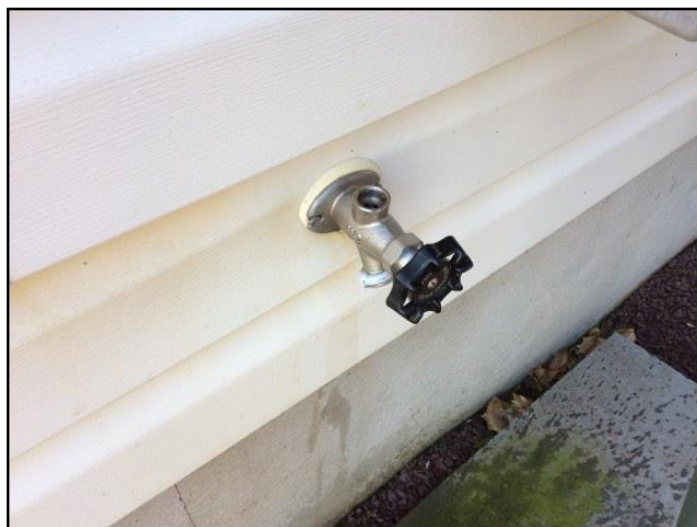
11. Condition: • Damage

The right side hose bib anti siphon is damaged.

Implication(s): Leakage | Equipment inoperative

20. Damage

Task: Repair by licensed expert

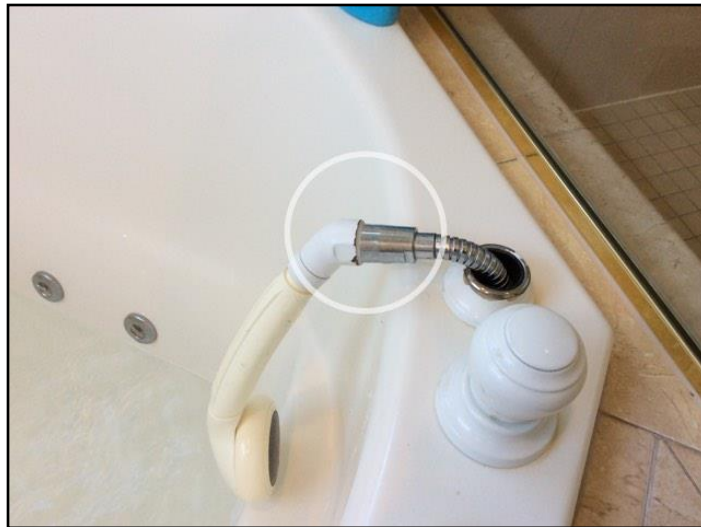
12. Condition: • Drip, leak

The master tub shower faucet leaks.

Implication(s): Chance of water damage to structure, finishes and contents

21. *Drip, leak*

Task: Repair

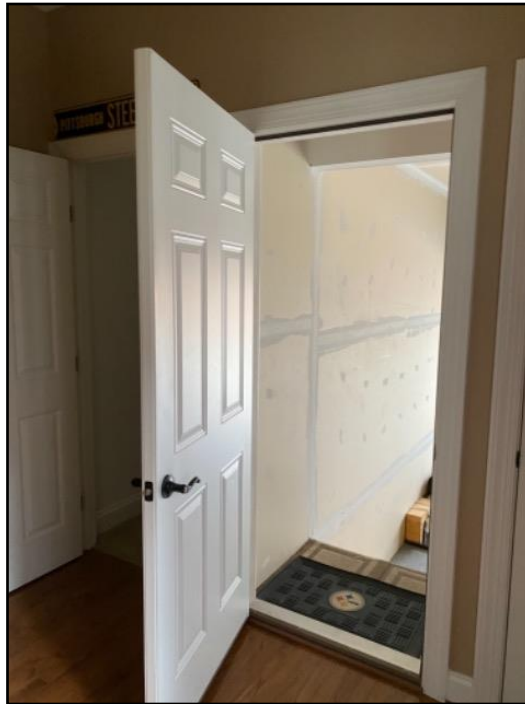
22.

13. Condition: • No self closer

Implication(s): Reduced fire and hazardous gas safety.

Task: Not required at the time of construction but a good upgrade.

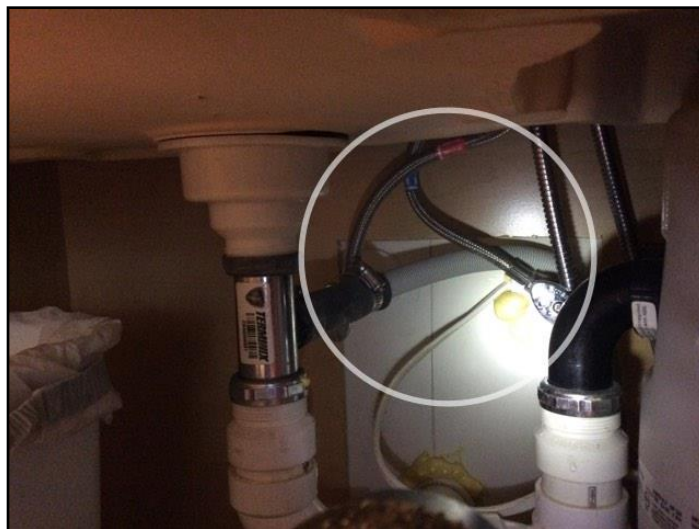
14. Condition: • Poor slope of drain hose. Strap the drain hose up so that it slopes down into the disposal to prevent back-flow into the drain or dishwasher.

23. Backflow prevention defective

Task: Repair

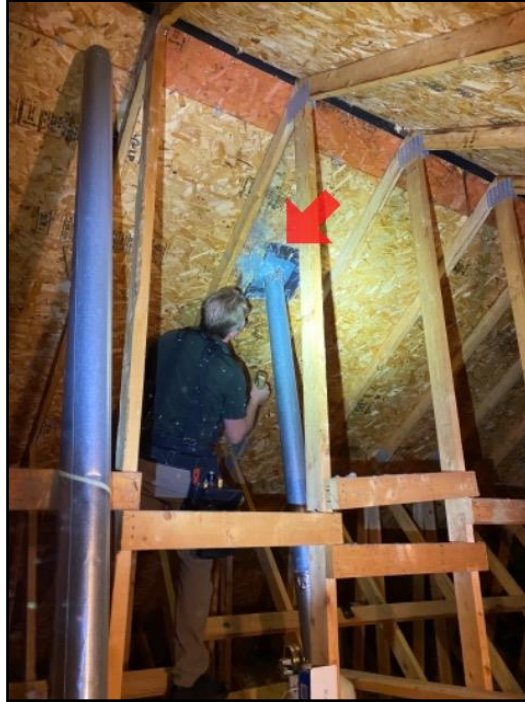
24.

Condition: • Dryer vent disconnected

15. Condition: • Dryer vent disconnected

Implication(s): Chance of damage to finishes and structure | Equipment not operating properly | Fire hazard | Odors, molds, etc.

Location: Attic at the attachment to the roof vent.

Task: Repair
